# **CANADIAN FORCES FLIGHT SAFETY INVESTIGATION REPORT (FSIR)**

## **FINAL REPORT**

**FILE NUMBER:** 1010-188732 (DFS 2-2-2)

**AIRCRAFT TYPE:** CF188 - Hornet

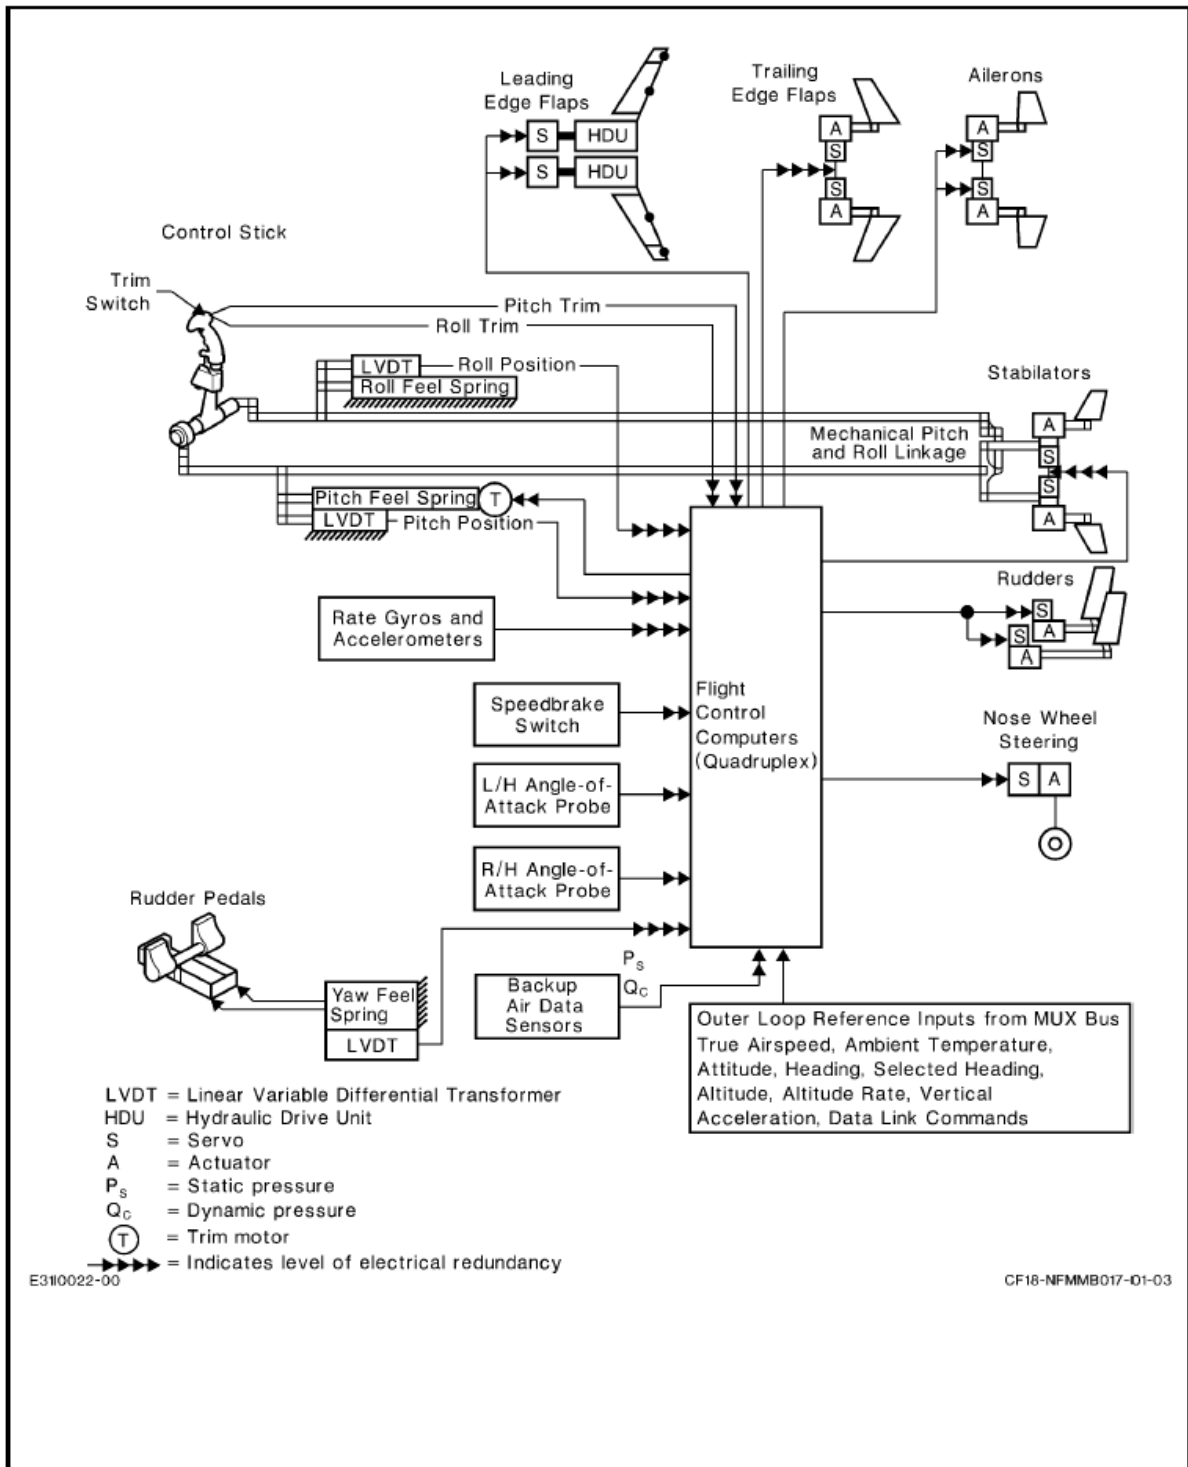
Fig 5. Flight control deflections at time of impact

Parts of all flight control surfaces were recovered (see Fig 4). The following deflections were estimated from measurements taken on the available parts of the flight controls and their actuators (see also Fig 5):

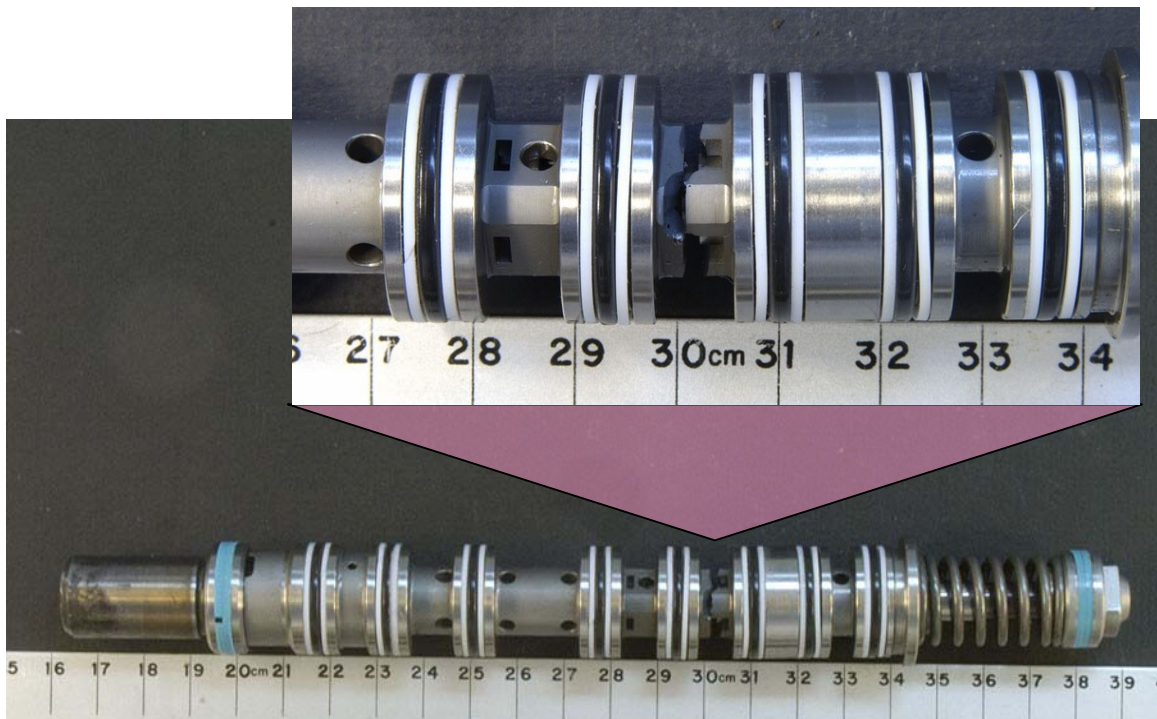
Fig 8. Disassembled MSV with close-up of spool fracture.
